# Test Report

| Sample Name | : Metal keyboard |

**Test item** : Salt Spray Test  
**Test standard** : IEC60068-2-11:1981  
**Test result** : PASS

## Test Item: Salt Spray Test

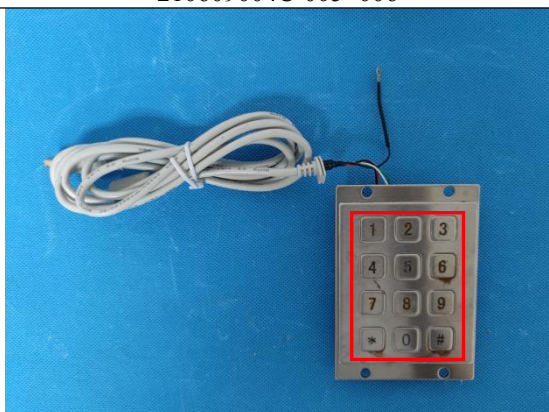
| Sample No. | Test result | Defect Area, A(%) | Protection rating | Judge |
|---|---|---|---|---|
| 210609005C-001 | After the test, red rust appeared on the sample surface and the USB interface surface. | $0.25 < A \leq 0.5$ | 7 | PASS |

210609004C-001 Red rust appears

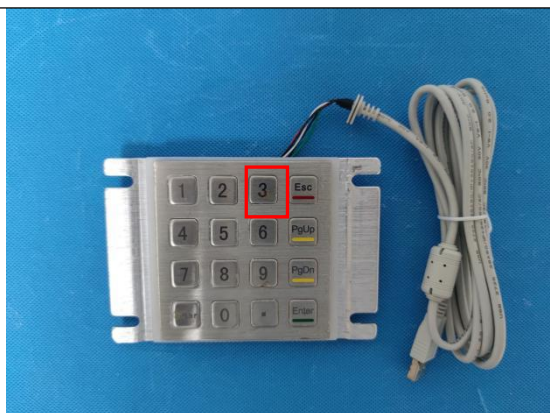
| Sample No. | Test result | Defect Area, A(%) | Protection rating | Judge |
|---|---|---|---|---|
| 210609005C-002 | Minor red rust appeared on the sample surface and the USB interface surface after the test. | $0.1 < A \leq 0.25$ | 8 | PASS |

210609004C-002 Mild red rust occurs

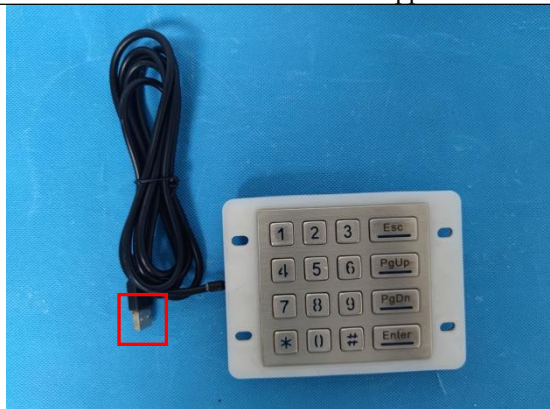
| Sample No. | Test result | Defect Area, A(%) | Protection rating | Judge |
|---|---|---|---|---|
| 210609005C-004 | Minor red rust appeared on the sample surface after the test. | $0 < A \leq 0.1$ | 9 | PASS |

210609004C-004 Mild red rust occurs

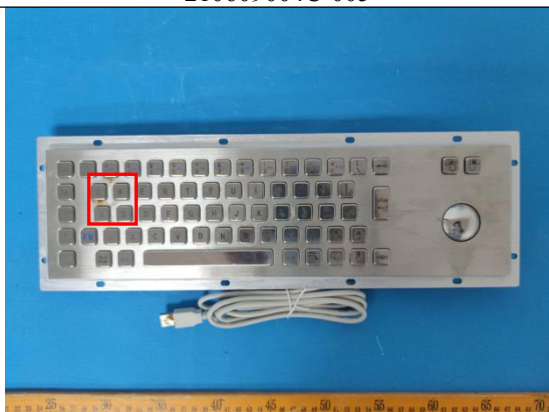
| Sample No. | Test result | Defect Area, A(%) | Protection rating | Judge |
|---|---|---|---|---|
| 210609005C-006 | Minor red rust appeared on the sample surface after the test. | $0.1 < A \leq 0.25$ | 8 | PASS |

210609004C-006 Mild red rust occurs
