## Environmental Commission Test Report

| <b>Equipment Under Test</b> | : | Waterproof Metal Keyboard |
| <b>Model No.</b> | : | D-8988 |
| <b>Test Items</b> | : | IP68 Test |

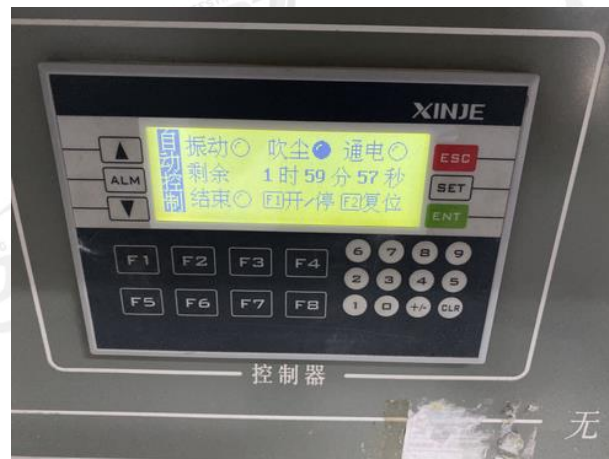
### 2.4.2. Test Photos

Note: During the test, the extraction rate of 40 to 60 volumes per hour is obtained the duration of the test is 2 h.

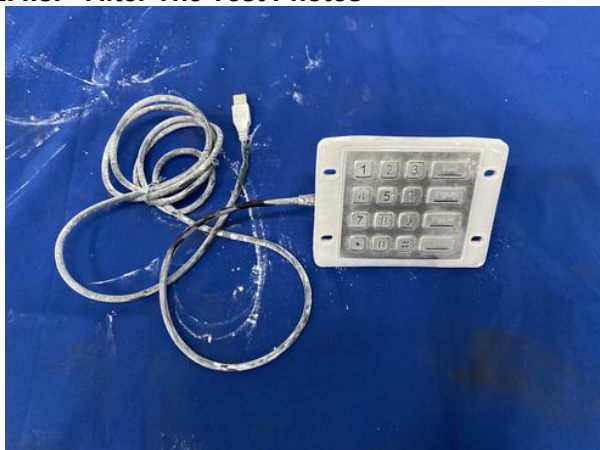
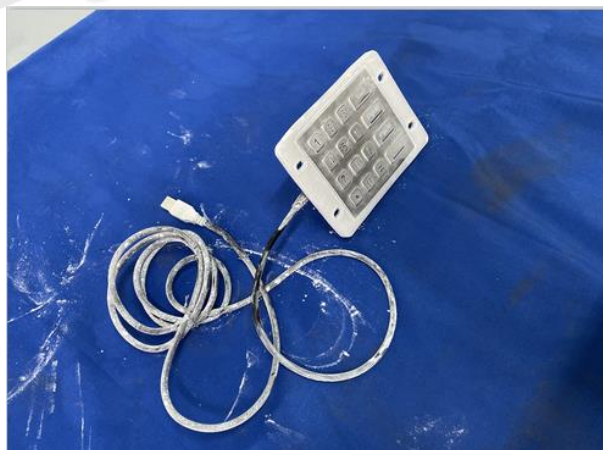
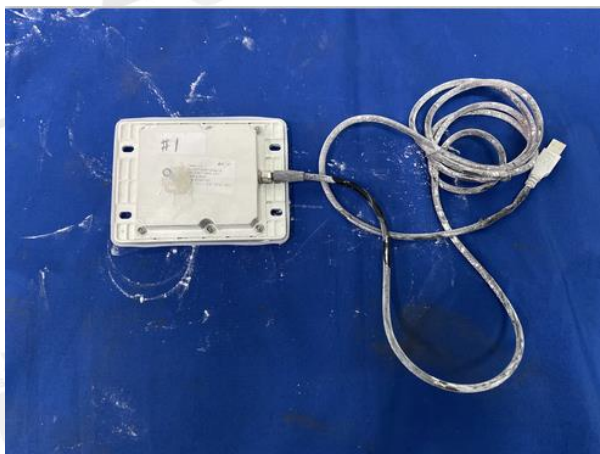
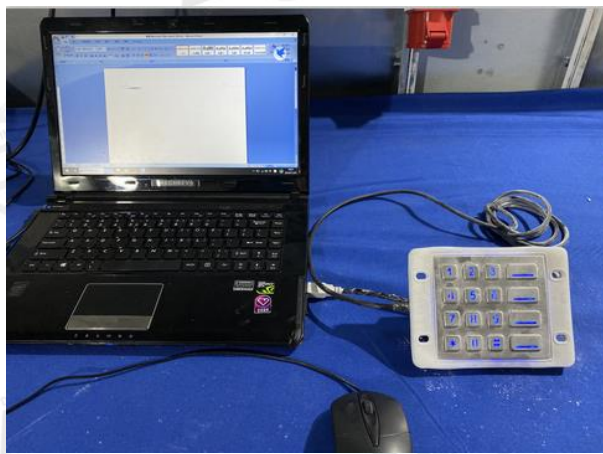
### 2.4.3. After The Test Photos

After the test, the appearance and function of the sample is normal. A dust-in phenomenon was found inside the disassembly inspection, but it did not affect the normal operation of the equipment or damage the safety (see 2.4.3 After the Test Photos for details). Meet the test requirements.

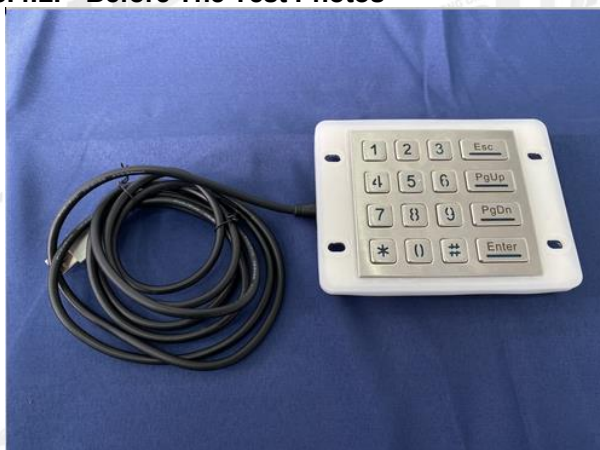
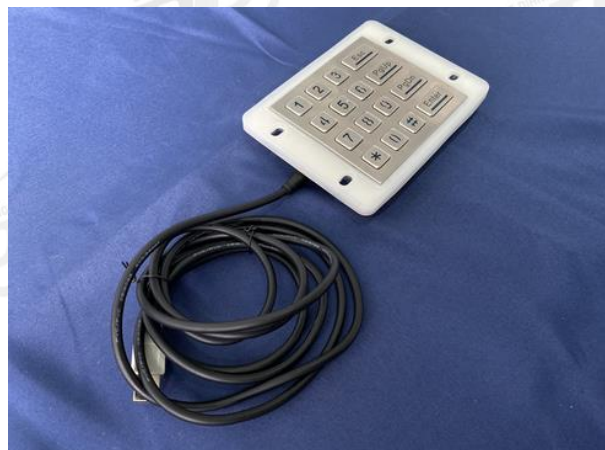
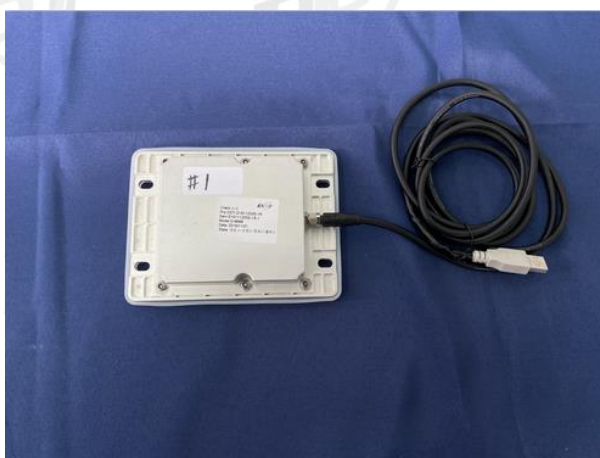
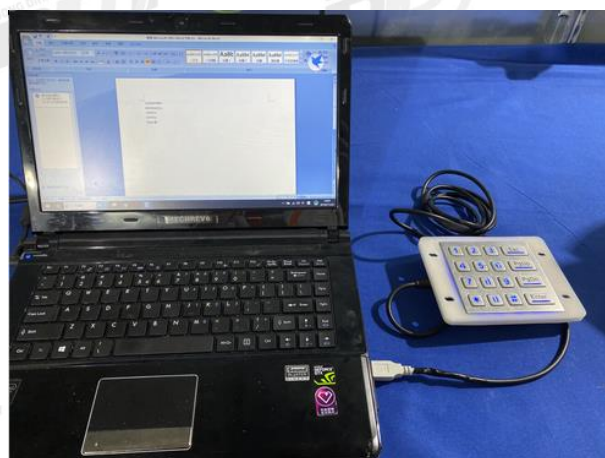
#### 3.4.1. Before The Test Photos

Before the test, the appearance and function of the sample is normal.

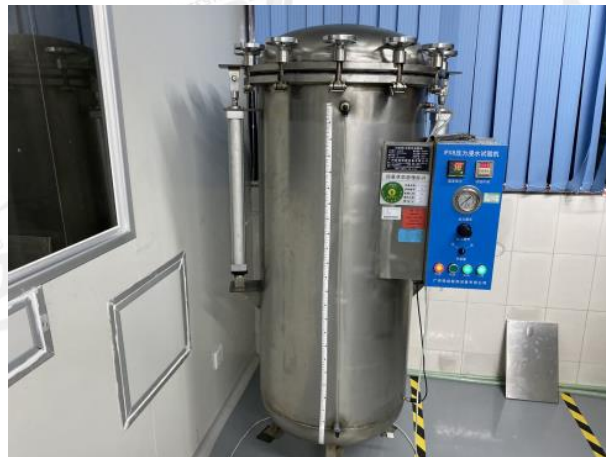
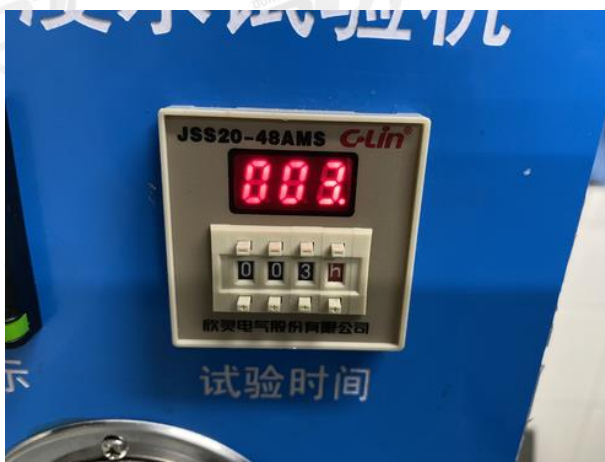
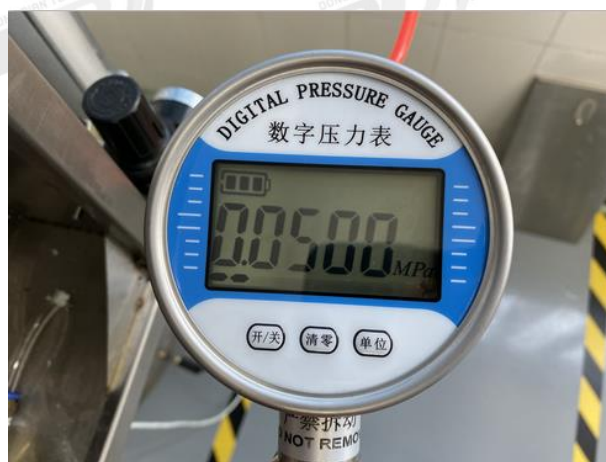
### 3.4.2. Test Photos

Note: The IPX8 pressure immersion tester digital pressure gauge can convert 10m water depth to 1Kg or 0.1Mpa, then the test condition of 5m water depth is displayed as 0.05Mpa on the digital pressure gauge.

Sample placement

overall arrangement

Test setup 1

Test setup 2

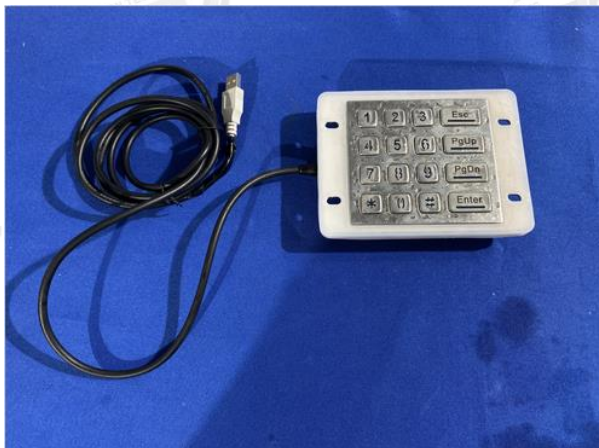
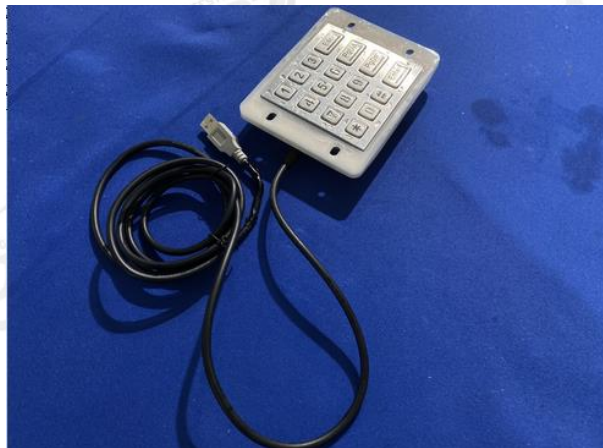
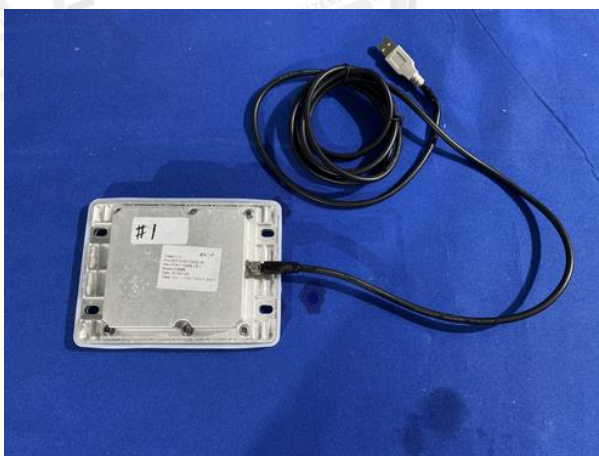
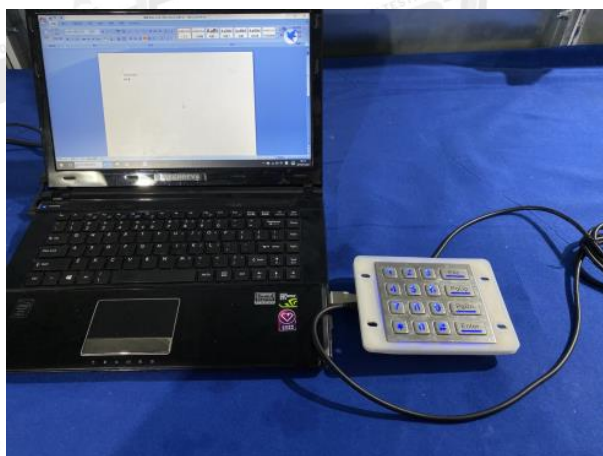
### 3.4.3. After The Test Photos

After the test, the appearance and function of the sample is normal. Water disintegration is found inside the disassembly inspection, but it did not affect the normal operation of the equipment or damage the safety (see 3.4.3 After The Test Photos for details). Meet the test requirements.
